Manhole Inspection Summary

Manhole # S41SS_001MH

Insp Date: **3/29/07 8:45 AM**

Location Address: **2600 KIRK AVE** Cross Street: **FRIENDSHIP ST**

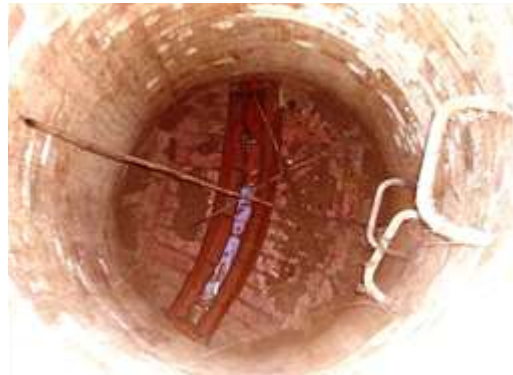
Top View

Adjsutment, Corbel and Barrel infiltration.
Corroded steps. Bench debris.

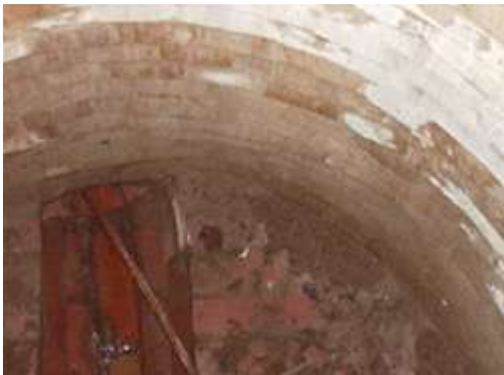
Defect

Corbel and Barrel infiltration.

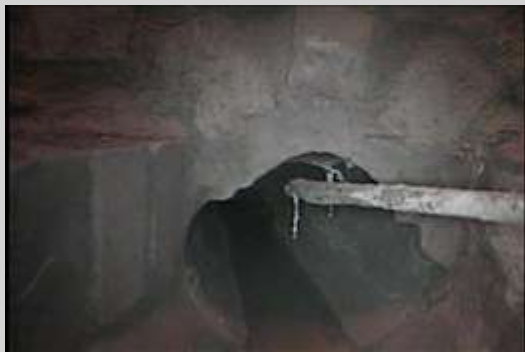
Pipe Out @ 12 O'Clock

Pipe Material: **Clay** ☐ Pipe Lined

Invert Depth: **7.86** (ft.) Flow Characteristics: **None**

Infiltration: **None** Pipe Seal Cond: **Unknown**

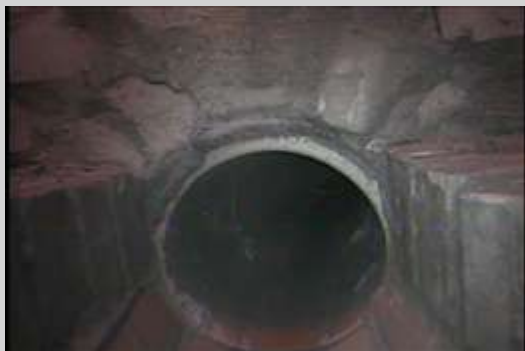
Pipe In @ 8 O'Clock

Pipe Material: **Clay** ☐ Pipe Lined

Invert Depth: **7.73** (ft.) Flow Characteristics: **None**

Infiltration: **None** Pipe Seal Cond: **Unknown**
